Aircraft Accident Report

**Loss of Control and Impact with Pacific Ocean
Alaska Airlines Flight 261
McDonnell Douglas MD-83, N963AS
About 2.7 Miles North of
Anacapa Island, California
January 31, 2000**

**NTSB/AAR-02/01
PB2002-910401
Notation 7263E
Adopted December 30, 2002**

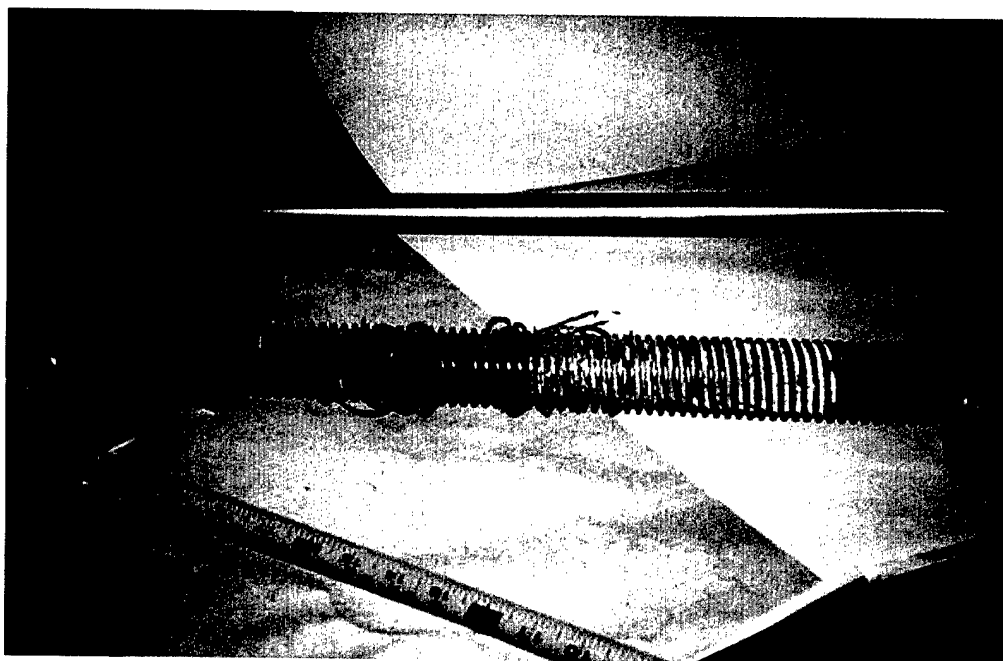
Corrosion pitting and red rust areas were found along most of the acme screw's length, with the heaviest areas of corrosion and rust along its lower half. Large areas of the acme screw were also found covered by white deposits, which chemical analysis determined were consistent with corrosion debris from the magnesium gearbox case attached to the top of the acme screw assembly. Figure 13 shows the acme screw thread remnants wrapped around the screw, the red rust areas, and the white deposits.

Figure 13. A photograph of the acme screw thread remnants wrapped around the screw, the red rust areas, and the white deposits.

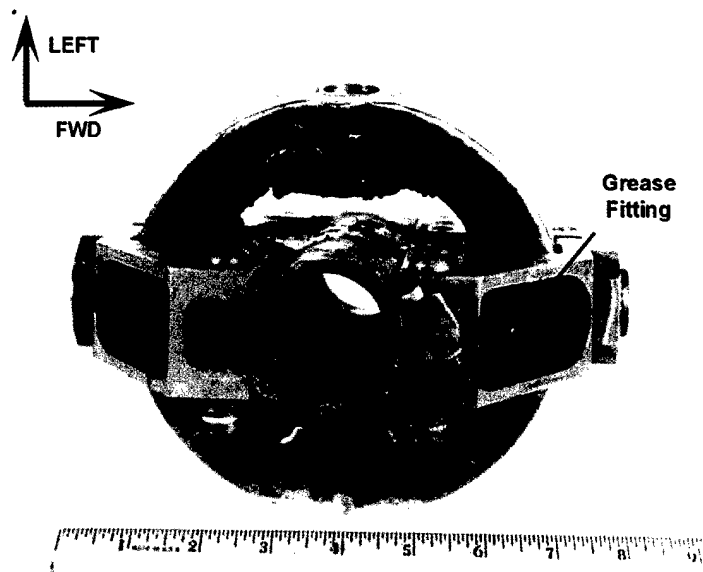
green-tinted, black and red grease deposits were found on the surrounding airplane structure.

Figure 15. A photograph of an overall view of the recovered acme nut assembly.

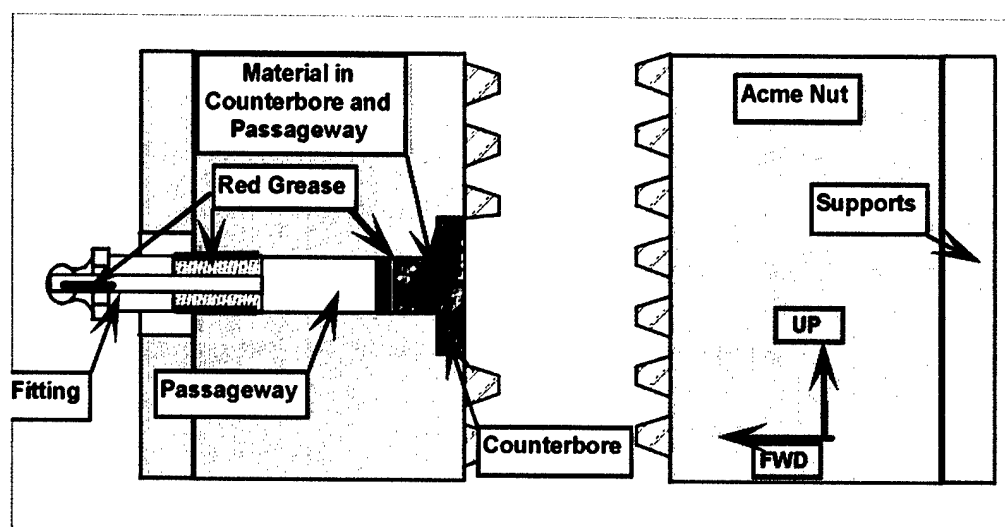
The acme nut has a grease fitting on the forward, upper side of the nut through which grease can be applied to the acme nut threads. A solid, black, claylike, dry residue coated with white, powdery material was found in the internal counterbore of the acme nut's grease passageway where it intersected the inside surface of the nut, as well as in the smaller diameter grease passageway behind the counterbore. When the grease fitting was

removed to allow collection of material samples from the grease passageway, translucent, reddish grease consistent with the appearance of Mobilgrease 28 was observed on the fitting's external threads. (Figure 17 shows a cross-section through the acme nut's grease passageway and fitting.) Traces of translucent, reddish grease were also found inside the grease passageway in the acme nut and in the bore of the grease fitting, a section distinct from the grease passageway. (Figure 18 shows the grease passageway and counterbore after the acme nut was sectioned.) Microscopic examination determined that the sample from the counterbore consisted mostly of black powdery material, larger chunks of black and white material, and particles of copper-colored metallic debris identified as acme nut material.

Figure 17. A diagram of a cross-section through the acme nut's grease passageway and fitting. Red areas denote the locations where red grease was found, and gray areas denote the location where the dry residue was found.

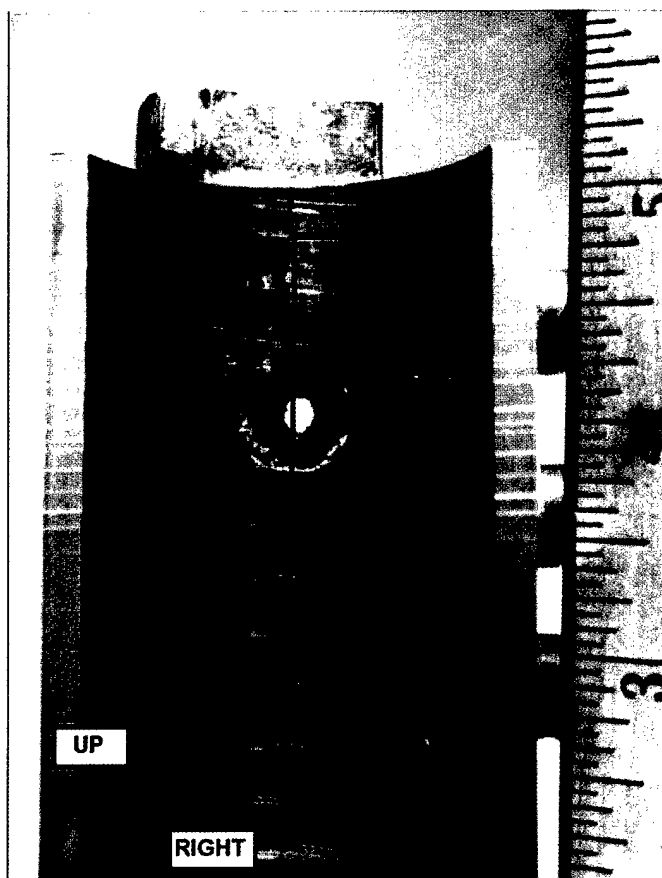
Figure 18. A photograph of the grease passageway and counterbore after the acme nut was sectioned.

Magnified visual inspections of the acme nut's interior after the nut was longitudinally sectioned confirmed the presence of the spiraling pattern consistent with the original location of the internal nut threads. For comparison with the accident acme nut interior, an exemplar nut was similarly sectioned.¹³⁶ The spiral patterns comprised a small raised ridge followed by a lustrous depression with spiral machining or wear marks transitioning into a dark band of surface deposits that rose to the next ridge. Under higher magnifications, longitudinal smearing and shear fractures were identified on the raised edges. The smearing and shearing directions were consistent with upward movement of the acme screw threads in relation to the nut body. Material was observed folded upward and smeared over adjacent surfaces along most of the ridges. Typical ridges were between 0.013 and 0.020 inch wide.

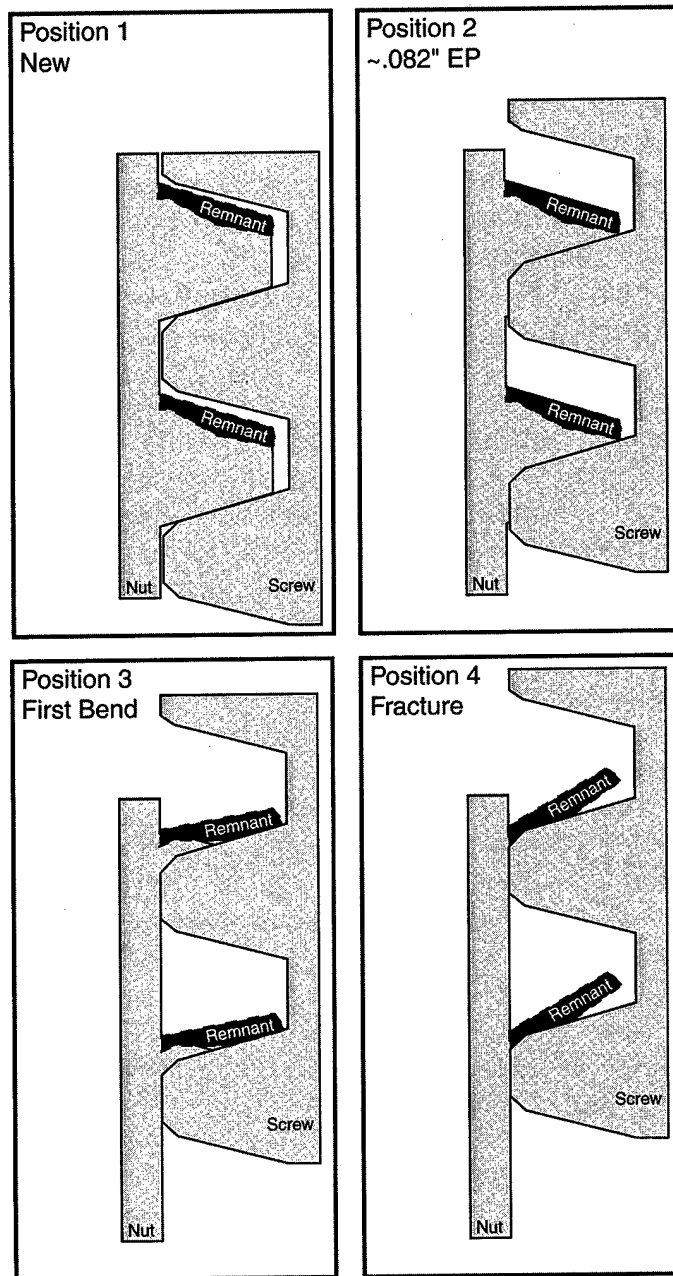
²¹⁶ It was theorized that, as the last of the acme nut thread remnants shear fractured and the screw threads tried to override the resulting ridges in the nut as the screw was pulled upward by aerodynamic loads and rotated circumferentially by the primary trim motor, the combined pinching and friction loads became greater than the combined aerodynamic and primary trim motor forces.

Figure 20. A graphical depiction of the stages of acme nut thread wear to the point of fracture.
